# HP Virtual Connect Firmware Upgrade Steps and Procedures

This document specifies the versions of firmware and software as well as recommended steps for updates to Virtual Connect (VC) version 4.01 or later from previous versions in HP BladeSystem single and multi-enclosure VC Domain environments. The firmware and software versions listed in this document have been tested as a solution set and are fully supported by HP.

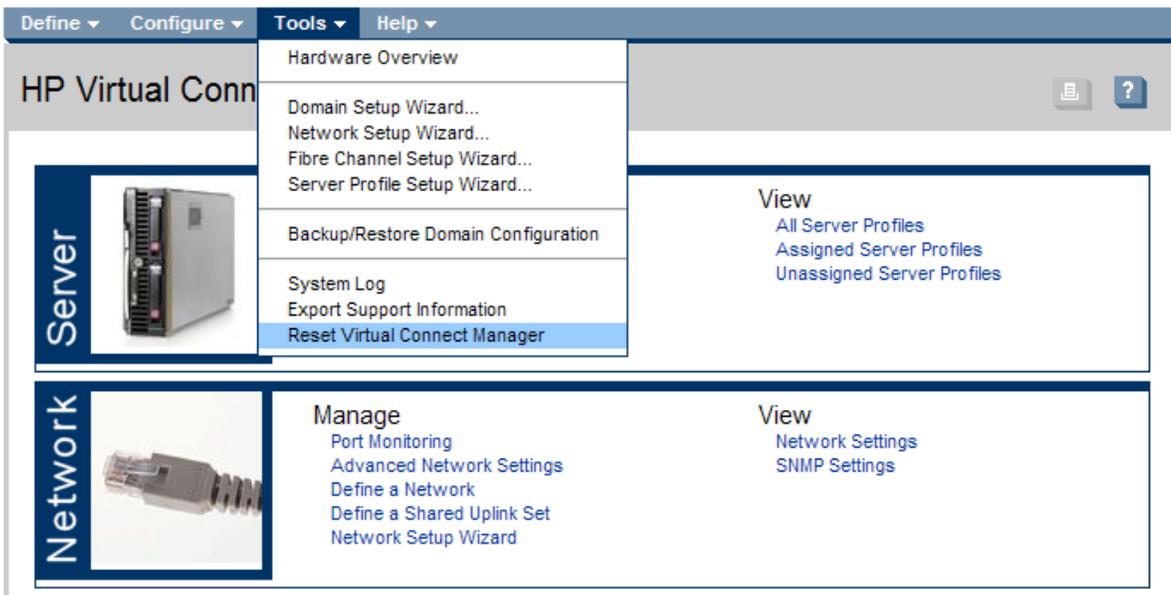
To reset the Virtual Connect Manager application running on the primary Virtual Connect Ethernet module from the VCM GUI, select “Tools→Reset Virtual Connect Manager”.

If a Reset of the Virtual Connect Manager is needed due to an incomplete or failed firmware update, please follow the steps outlined below to perform this operation. The Network and FC SAN connectivity for servers in the Domain is not disturbed during reset or failover of the Virtual Connect Manager.

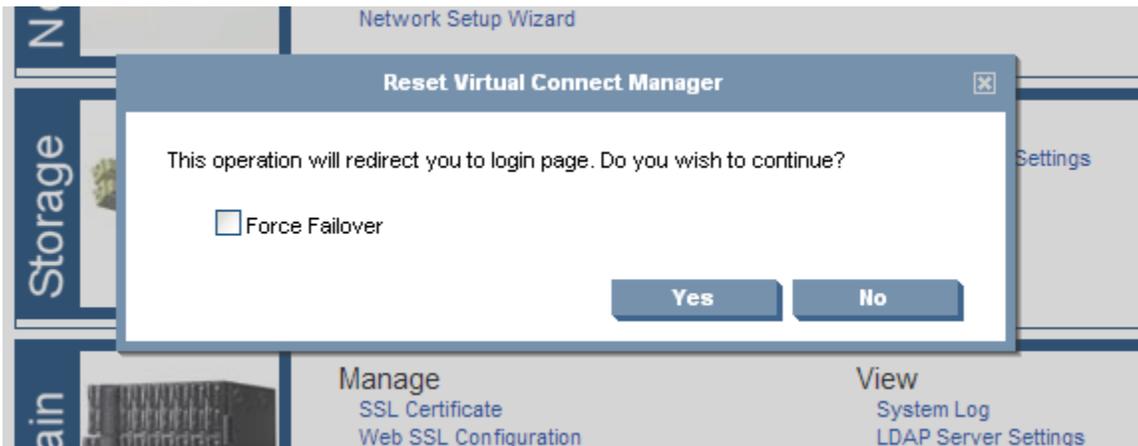
The Reset Virtual Connect Manager popup is displayed.

- If the Force Failover checkbox is selected and a Virtual Connect Ethernet module is available in the horizontally adjacent IO Bay, the VCM UI is redirected to that Ethernet module after the Virtual Connect Manager reset completes.
- If the Force Failover checkbox is not selected or a Virtual Connect Ethernet module is not available in the horizontally adjacent IO Bay, the Virtual Connect Manager restarts on the current Ethernet module, and the logon screen for the current Ethernet module is displayed after the Virtual Connect Manager reset completes.
- Reset times depend on the size and complexity of the VC domain configuration.
